AMMRC TR 78-11

DEVELOPMENT OF NONDESTRUCTIVE TESTING TECHNIQUES FOR
HIGH PERFORMANCE CERAMICS

JANUARY 1978

FINAL REPORT - CONTRACT DAAG46-76-C-0022

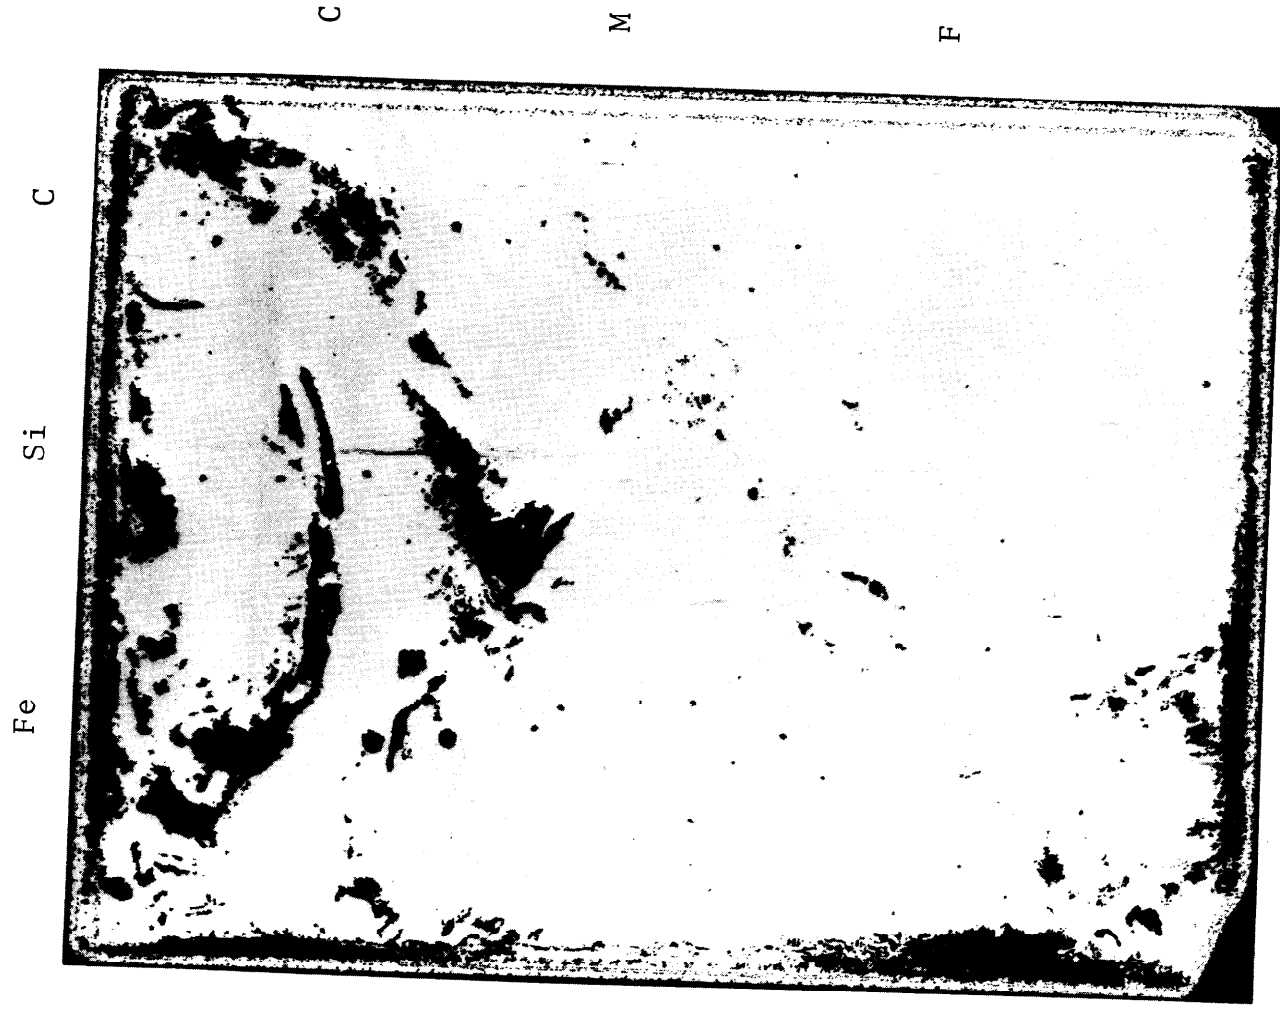
Figure 10. C-scan recording of NC-435 SiC #1 billet
in machined condition.

Figures 6 through 13 show pulse-echo C-scan recordings at 25 MHz frequency of the NC-132 and NC-435 billets following surface machining. The ultrasonic test reveals the presence of many defects in the billets that are not listed on the seed location maps. Ultrasonic indications from the coarse and medium seeded contaminants are obvious on the recordings. Identification of the fine contaminant indications on the C-scans is not quite as simple except in a few instances such as the Fe in NC-132 bottom billet and the Si in NC-132 top. Generally, ultrasonic indications

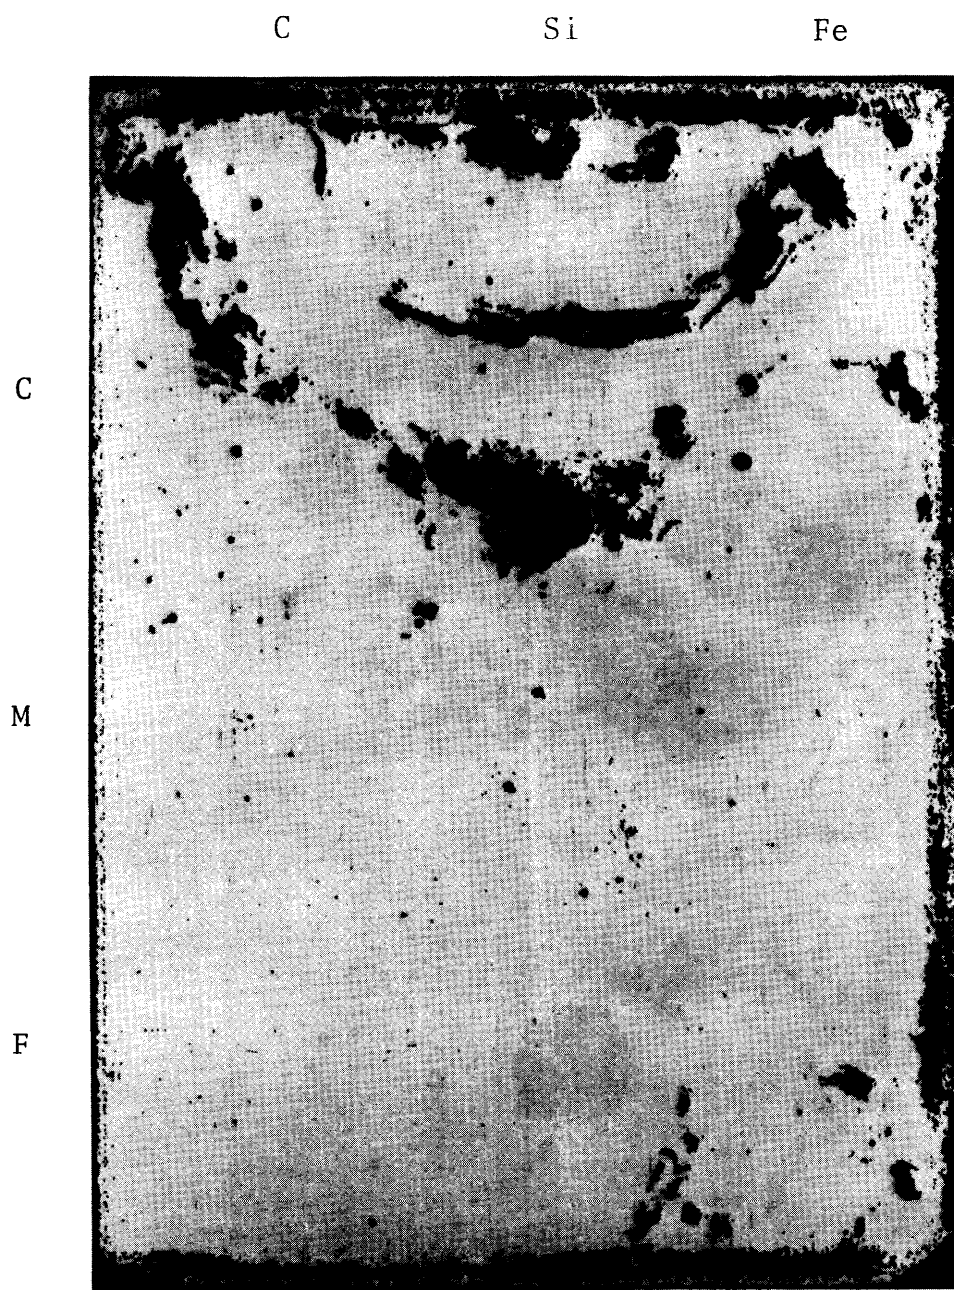
Figure 11. C-scan recording of NC-435 SiC #1 billet, turned over, in machined condition.

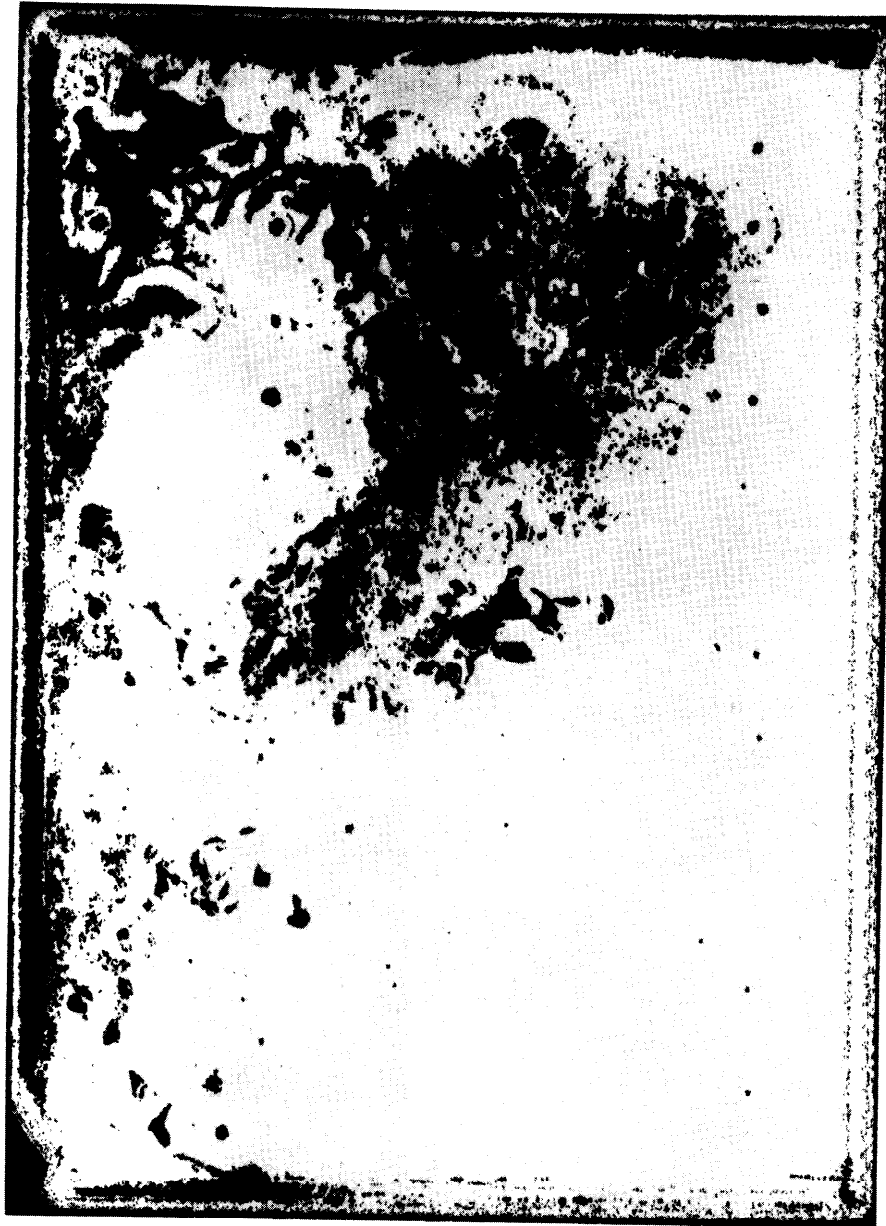
Figure 12. C-scan recording of NC-435 SiC #2 billet in machined condition.

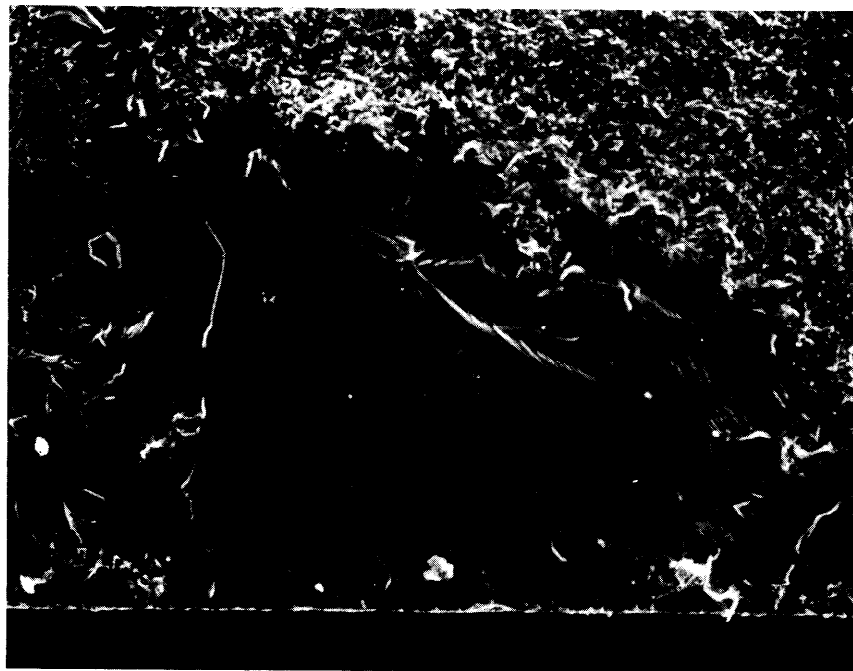
Figure A-7B. Fracture origin (silicon inclusion) in specimen 1-Fe-C-1 at 50X (above) and 200X (below).

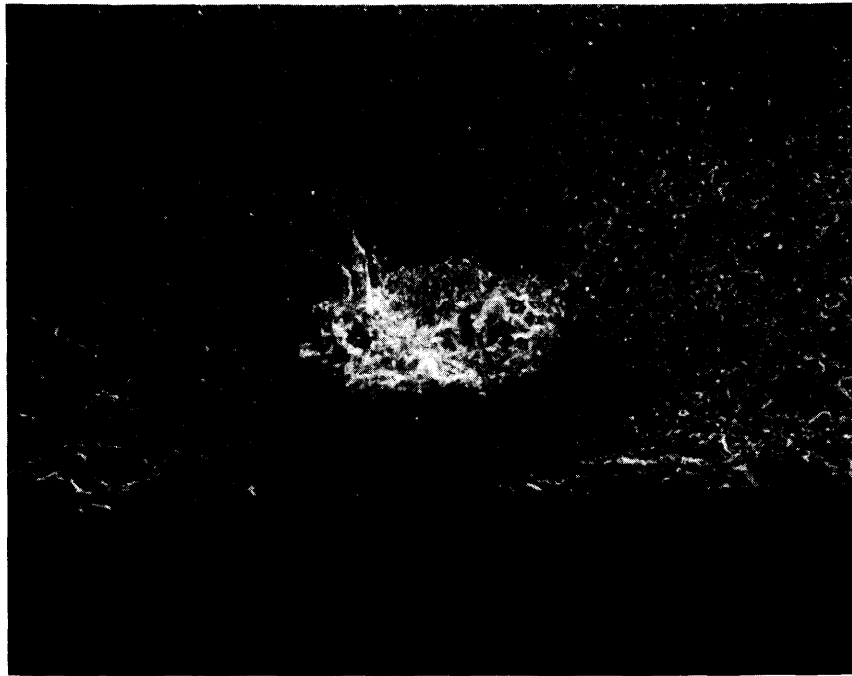
Figure A-8B. Fracture origin (iron inclusion) in specimen B-Fe-F-1 at 50X (above) and 1000X (below). Test temperature was 1093°C.

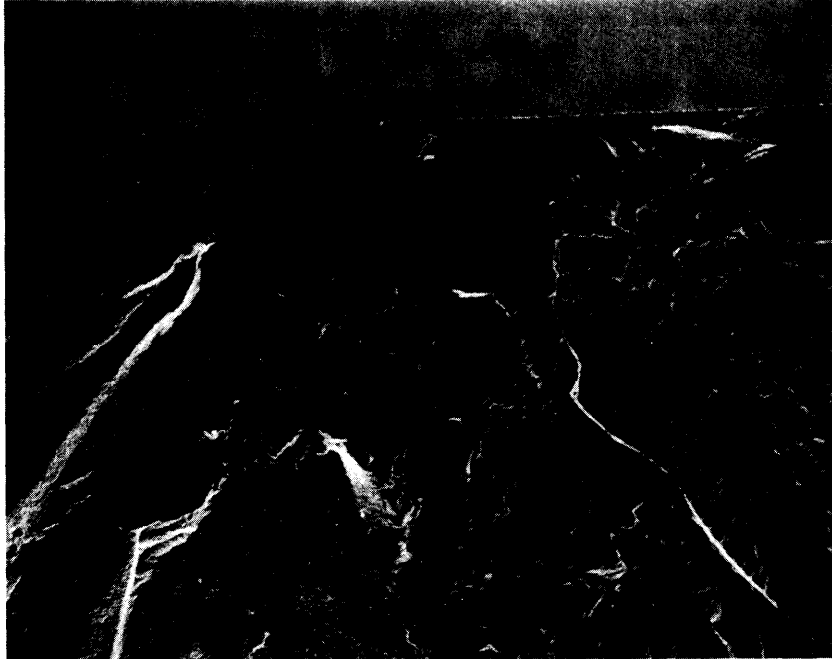
Figure A-12B. Fracture origin of specimen B-WC-C-2 at 50X (above) and 500X (below). Inclusion is of porous, unintentional type.
